**Flood Control Project Maintenance
Levee Inspections**

Maintenance Issue Types Only, Levee Inspection Report By Mile - Fall 2019

Reclamation District No. 0010 Honcut

Waterway	Bank	Unit Miles	Inspection Start/End	Inspector
Unit No. 01 Simmerly Slough	Right	7.65	11/19/2019 11/19/2019	Sterling York

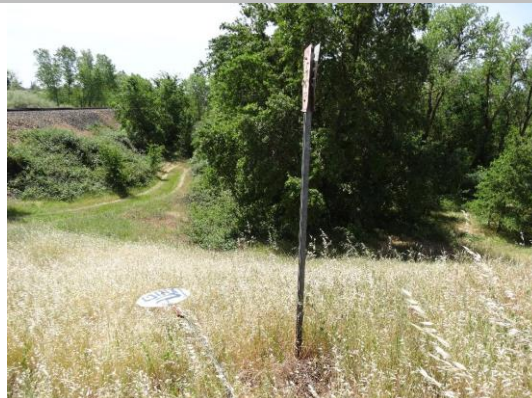
Photo 2 of 3 : UCIP_FA_2019_27791_51500.jpg

Comment Code						
Inspector Comment						
DS_ID:21268 FS_ID:27791 EP_NO: N/A Repair Type: Non-Urgent Crossing Status: Found UCIP Comments: 04/29/2013 Vegetation has been cleared from slope. This crossing is referenced in the USACE Periodic Inspection as item USACE_CESPK_HON1_2013_p_0158. (DWR UCIP - O. Magana) FIELD_STRUCT_DESC: 24-inch corrugated metal gravity drainage pipe through the levee, 30 feet below the crown. Flap gate on the waterside (WS) end. Slide gate on the landside (LS) end. Concrete saddle and apron on the WS. [Additional Reference(s): DWR Levee Log, 2005. USACE Sacramento O&M Manual 151, May 1953, (Station 1+00)]. FS Date: 4/29/2013

Pipe marker visible on ground--sign has been bent.

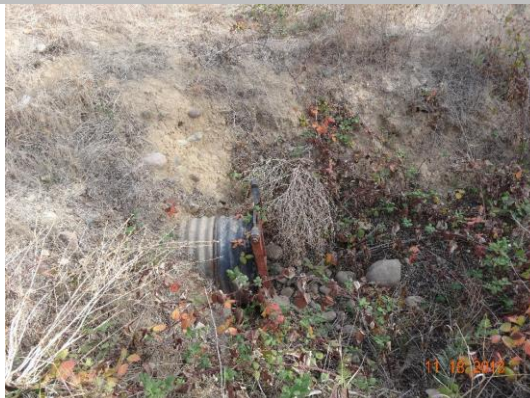
Photo 3 of 3 : UCIP_FA_2019_27791_51504.jpg

Comment Code						
Inspector Comment						
DS_ID:21268 FS_ID:27791 EP_NO: N/A Repair Type: Non-Urgent Crossing Status: Found UCIP Comments: 04/29/2013 Vegetation has been cleared from slope. This crossing is referenced in the USACE Periodic Inspection as item USACE_CESPK_HON1_2013_p_0158. (DWR UCIP - O. Magana) FIELD_STRUCT_DESC: 24-inch corrugated metal gravity drainage pipe through the levee, 30 feet below the crown. Flap gate on the waterside (WS) end. Slide gate on the landside (LS) end. Concrete saddle and apron on the WS. [Additional Reference(s): DWR Levee Log, 2005. USACE Sacramento O&M Manual 151, May 1953, (Station 1+00)]. FS Date: 4/29/2013

View of pipe and flap gate located on waterward side.

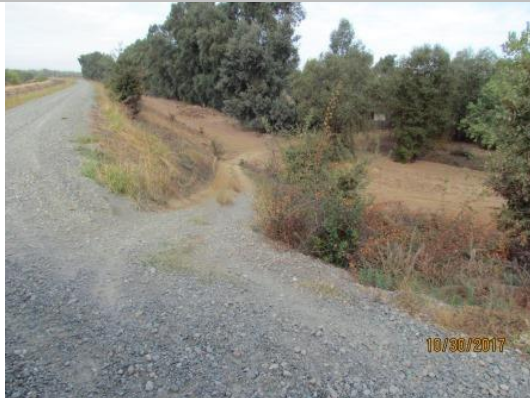
Photo 1 of 1 : FA_2019_RD0010_163_48_20190904_00009.jpg

LM Start	0.72	Rating **	A/W	Issue No.	48
LM End	0.72	Issue Type +	Ma	Location *	LS
Category	Earthen Levee			GPS Latitude/Longitude	
				Start	End
Item	Slope Stability			39.161198 °	39.161198 °
				-121.597102 °	-121.597102 °
DWR ID	DWR_RD0010_01_f_2013_48				
Comment Code					
S3 : Repair the levee slope damaged by vehicle traffic and prevent access where possible.					
Inspector Comment					
Ramp is caused by constant ATV foot traffic use on levee slope, there is no sign of separation, cracking, or caving, Fall 2019.

View of the slope stability caused by foot traffic on the landward side of the levee looking downstream.

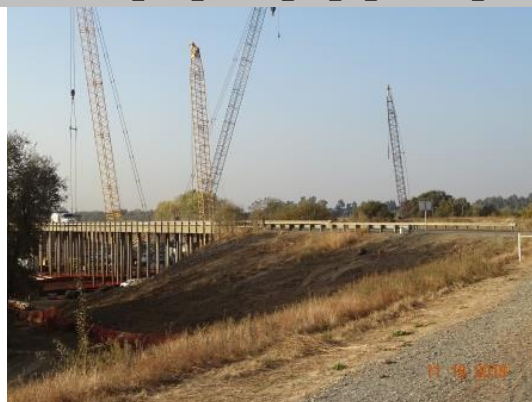
Photo 1 of 2 : FA_2019_RD0010_163_28_20191119_00082.jpg

LM Start	1.28	Rating **	A	Issue No.	28
LM End	1.42	Issue Type +	Ma	Location *	CR
Category	Earthen Levee			GPS Latitude/Longitude	
				Start	End
Item	Crown Surface / Depressions / Rutting			39.168075 °	39.169123 °
				-121.591579 °	-121.589389 °
DWR ID	DWR_RD0010_01_f_2019_28				
Comment Code					
Inspector Comment					
Construction of the new Highway 70 Bridge, this section is not inspected this fall, Fall 2019.

View looking downstream of the construction of the new Highway 70 Bridge, Fall 2019.

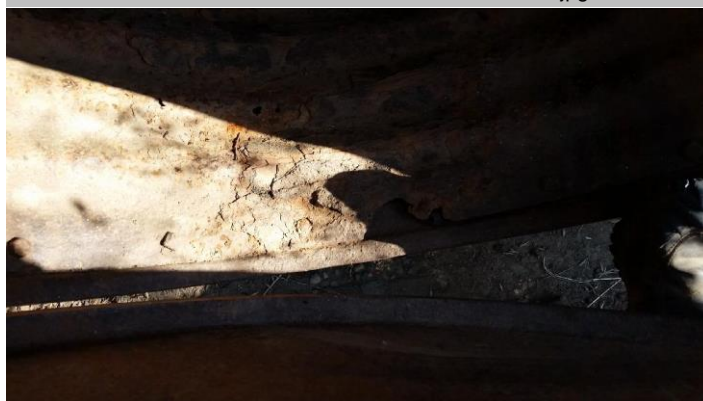
Photo 3 of 3 : UCIP_FA_2019_53136_75321.jpg

DS_ID:21318
FS_ID:53136
EP_NO: N/A
Repair Type: Urgent
Crossing Status: Found
UCIP Comments: 10/18/2018 No change since the last inspection. Pipe remains Urgent due to deteriorated wall (visible holes present inside) near WS flap gate. This pipe is part of DWR's Deferred Maintenance Project (DMP). According to LMA representative, the video inspection of DMP pipes is expected to be completed next year. Levee height is about 25-30 feet. (O. Magana - DWR UCIP)7/01/2016 Pipe wall in poor condition--deteriorated pipe wall indicated by holes at the inlet and outlet pipe collar. Recommend internal integrity inspection of the pipe through the levee to determine extent of damage. (DWR UCIP - omagana)4/29/2013 Holes present on pipe wall. Need to contact owner to notify of issue with pipe. Also need to contact DWR Inspector and CVFPB to determine how to address issue. This crossing is referenced in the USACE Periodic Inspection as item USACE_CESPK_HON1_2013_p_0140. Pipe should be 30-inch instead of 36-inch mentioned Periodic Inspection. (DWR UCIP - omagana) FIELD_STRUCT_DESC: 30-inch corrugated metal gravity drainage pipe through the levee, approximately 30 feet below the crown. Two corrugated metal cutoff walls around the pipe on each side. Saddle and splash apron at the waterside (WS) discharge point. Concrete headwall and sluice gate on the landside (LS). [Additional Reference(s): DWR Levee Log, 2005. USACE Sacramento O&M Manual 151, May 1953, (Station 10+38)].

Deteriorated pipe wall at the outlet (WS).

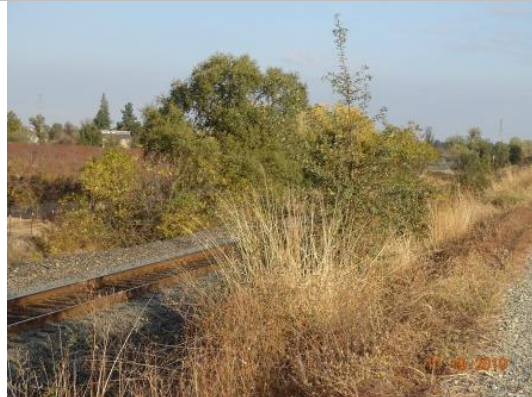
Photo 1 of 1 : FA_2019_RD0010_163_34_20191119_00084.jpg

View looking upstream landside of small starter trees that need to be removed, Fall 2019.

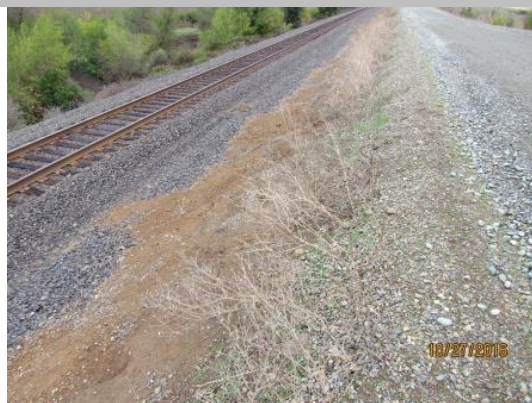
Photo 1 of 1 : FA_2019_RD0010_163_60_20190904_00017.jpg

View of squirrel holes on the landside slope and toe, no rodent activity was observed.

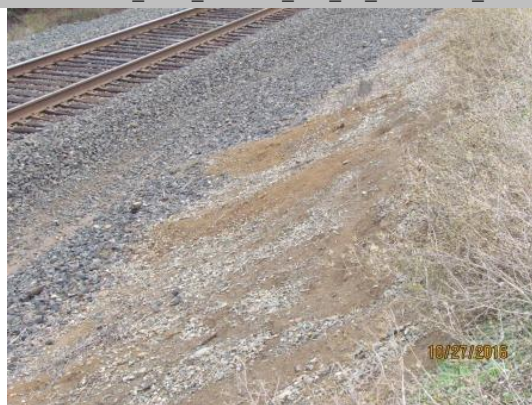
Photo 1 of 1 : FA_2019_RD0010_163_59_20190904_00016.jpg

LM Start	2.63	Rating **	M	Issue No.	59
LM End	2.63	Issue Type +	Ma	Location *	LS
Category	Earthen Levee			GPS Latitude/Longitude	
				Start	End
Item	Animal Control			39.183967 °	39.183967 °
				-121.583989 °	-121.583989 °
DWR ID	DWR_RD0010_01_s_2016_59				
Comment Code					
A3 : No rodents visible, but rodent burrows visible; need to backfill and compact or grout burrows.					
Inspector Comment					
Squirrel holes still are visible but there is no sign of activity, Fall 2019.

View of squirrel holes on the landside slope and toe, no rodent activity was observed.

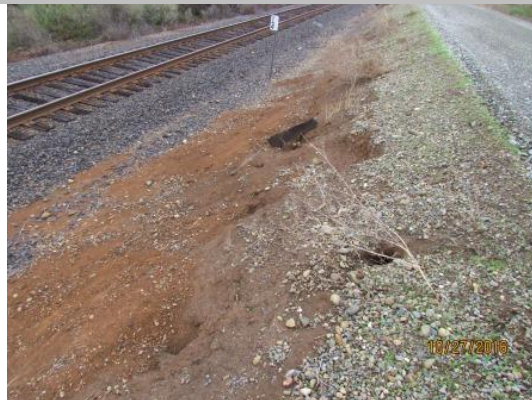
Photo 1 of 1 : FA_2019_RD0010_163_57_20190904_00014.jpg

View of squirrel holes on the landside slope and toe, no rodent activity was observed.

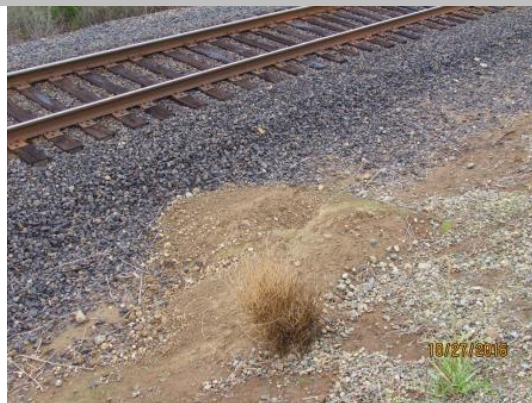
Photo 1 of 1 : FA_2019_RD0010_163_52_20190904_00013.jpg

View of squirrel holes on the landside slope and toe, no rodent activity was observed. Fall 2016.

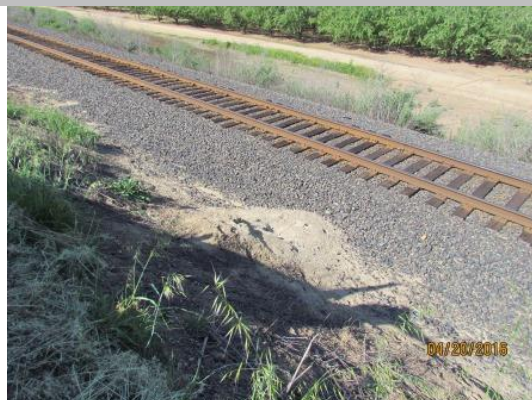
Photo 1 of 1 : FA_2019_RD0010_163_51_20190904_00012.jpg

View of large burrow on landside.

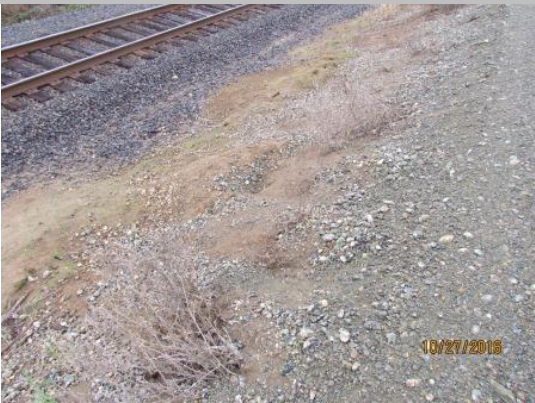
Photo 1 of 1 : FA_2019_RD0010_163_50_20190904_00011.jpg

View of squirrel holes on the landside slope and toe, no rodent activity was observed.

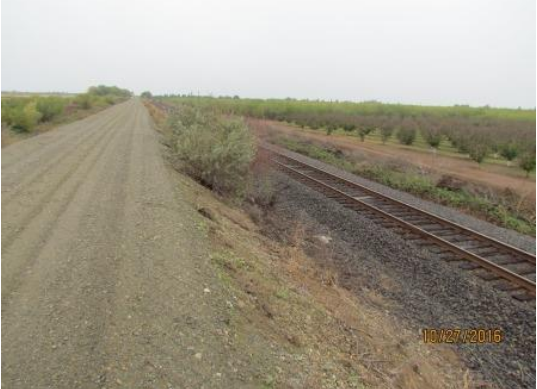
Photo 1 of 1 : FA_2019_RD0010_163_47_20190904_00008.jpg

View of a small willow tree that should be removed on the landside looking downstream.

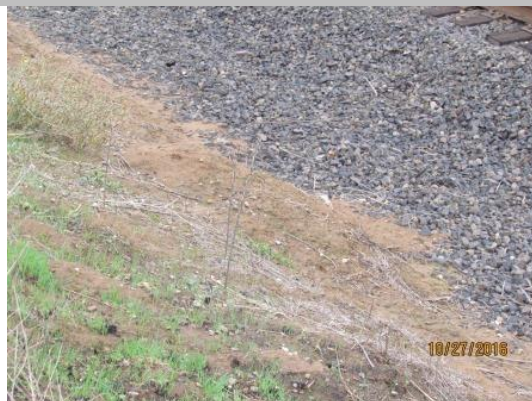
Photo 1 of 1 : FA_2019_RD0010_163_46_20190904_00007.jpg

View of squirrel holes on the landside slope and toe, no rodent activity was observed.

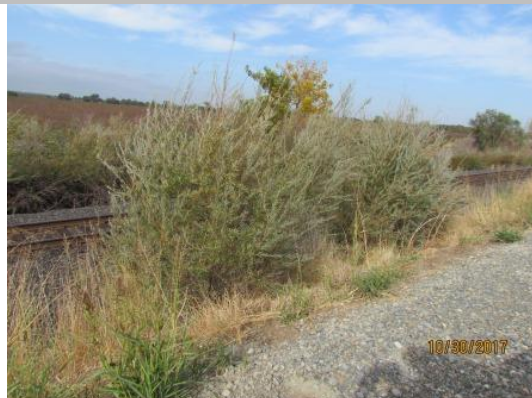
Photo 1 of 1 : FA_2019_RD0010_163_37_20190904_00003.jpg

View of small willow trees on the landside slope looking upstream.

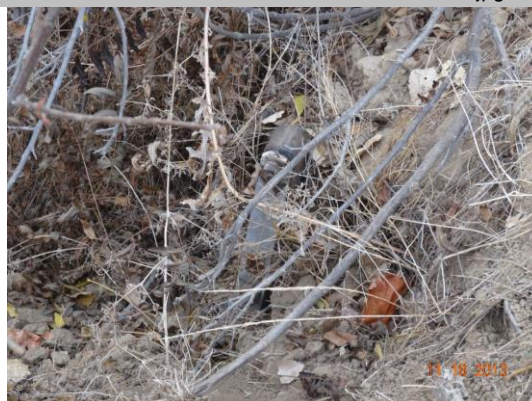
Photo 3 of 3 : UCIP_FA_2019_27533_51138.jpg

Buried flap gate on waterward side.

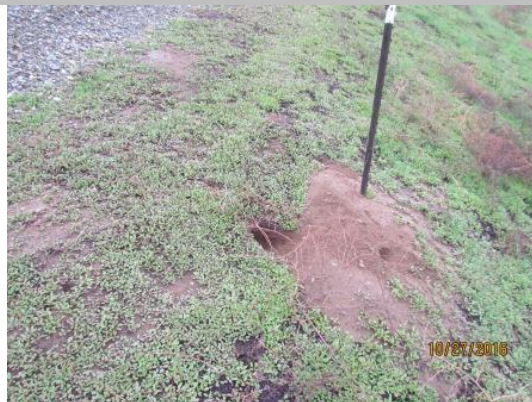
Photo 1 of 1 : FA_2019_RD0010_164_28_20190904_00003.jpg

View of squirrel hole on the waterside looking downstream.

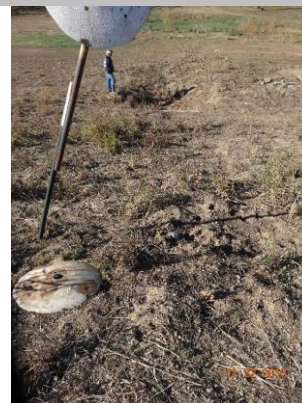
Photo 2 of 3 : UCIP_FA_2019_24825_44663.jpg

View of waterward slope--burrow activity present.

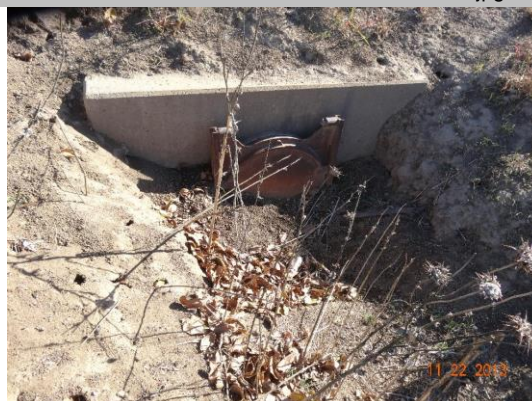
Photo 3 of 3 : UCIP_FA_2019_24825_44662.jpg

Flap gate located on waterward side--debris blocking gate.

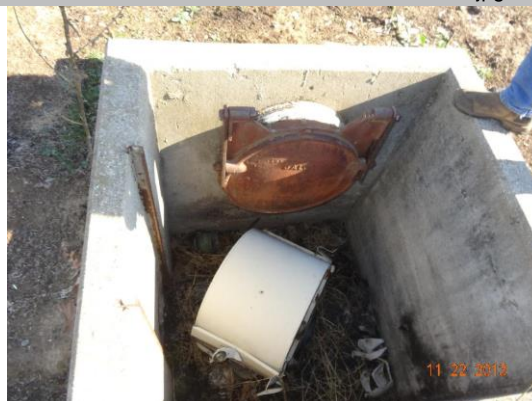
Photo 2 of 3 : UCIP_FA_2019_24769_44453.jpg

View of flap gate located inside concrete distribution box. Debris scattered inside box.

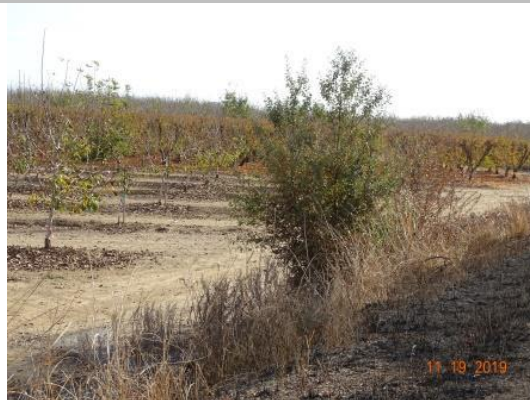
Photo 1 of 1 : FA_2019_RD0010_164_56_20191120_00106.jpg

View looking downstream landside at a small starter tree that needs to be removed, Fall 2019.

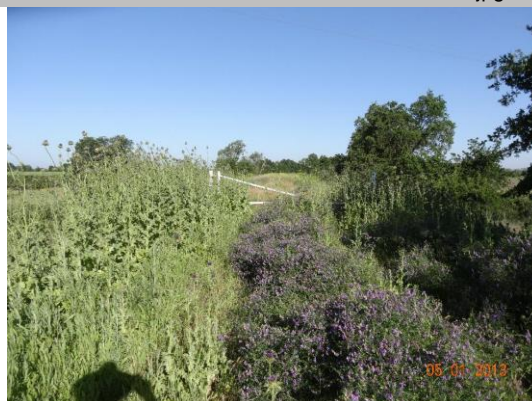
Photo 2 of 2 : UCIP_FA_2019_24883_44821.jpg

View of levee crown--dense vegetation.
